Report on the Paducah Gaseous Diffusion Plant Metals Recovery Program

*Department of Energy
Oak Ridge Operations
December 2000*

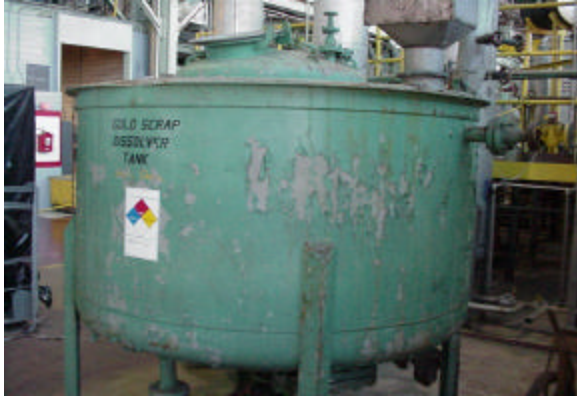
Exhibit 2 - Gold Scrap Dissolver Tank.

The gold recovery process is outlined in PGDP procedure, CH-358, *Gold Recovery in C-400*. The steps outlined in this procedure were corroborated with interviews and document reviews. After accumulation of gold-bearing scrap in C-746A, the material was transported in lots to the C-400 gold recovery area located in the west bay at the north end of the building. When received, the Chemical Operations Department prepared a *Rare and Precious Metal Certificate* (Form UCN-1672). The material was then processed in a nitric acid solution in the Gold Scrap Dissolver Tank (**Exhibit 2**).

The tank had steam heating coils to increase the action of the nitric acid. The gold scrap remained in this tank for several hours and occasionally overnight to allow for full dissolution of the scrap. Everything except plastic and gold was dissolved. Gold leaf that floated on top of the solution was skimmed off and the nitric acid solution was decanted into the filtrate settling tank; the remaining solids were placed on the gold wash table (**Exhibit 3**). The table had a recirculating water system to continually flush water over the materials removed from the Gold Scrap Dissolver Tank. A screen at the deeper end of the wash table would accumulate gold scrap that was freed from the dissolved parts. This gold was placed in cheesecloth-like “socks,” dried in an oven, and compressed into a small cylinder

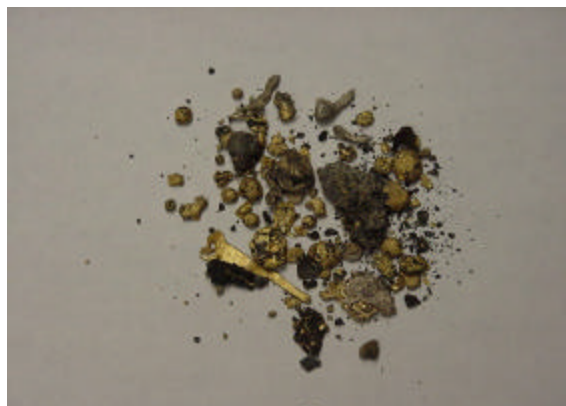
Exhibit 6 - Gold slag.

- C Gold slag believed to be from the gold recovery process contained very low levels of uranium contamination.

A gold slag sample (**Exhibit 6**) believed to be from the C-400 gold recovery operation contained very low levels of radioactivity. Although the origin cannot be proven, this gold slag was given to the investigation team by an engineer involved in the gold recovery program. The slag was analyzed by mass spectrometry and gamma spectroscopy. All isotopes except ^{238}U were less than their respective minimum detectable activities (MDAs). Concentrations of the ^{238}U were low (8.65 pCi/g from gamma spectroscopy on the total sample).

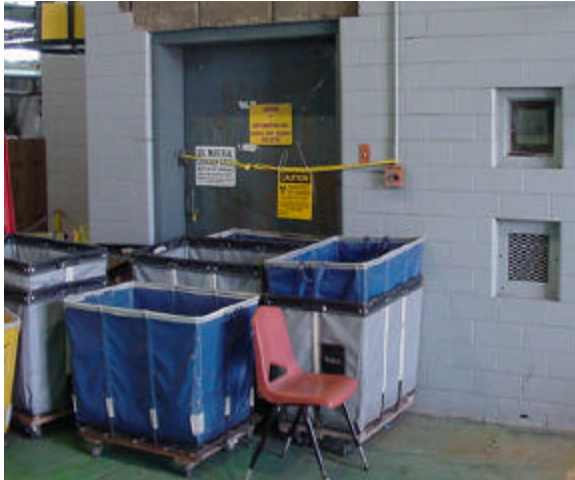
Exhibit 7 - Neptunium Recovery Room.

Because the gold was recovered and melted in C-400, one of the more highly contaminated buildings at PGDP, there was potential for cross-contamination of the gold ingots produced there. Drums of gold-plated weapons parts received after disassembly in C-746A were stored in what is now referred to as the Neptunium Recovery Room of C-400 (**Exhibit 7**). Surveys for removable contamination on items stored in the room for many years were recently conducted. Levels were below DOE's unrestricted use limits for beta emitters and only slightly above the unrestricted use limits for transuranics. Since

- A bucket of silver slag found in the C-400 Neptunium Recovery Room was analyzed by ICP mass spectrometry and found to contain 2,100 pCi/g of technetium-99.

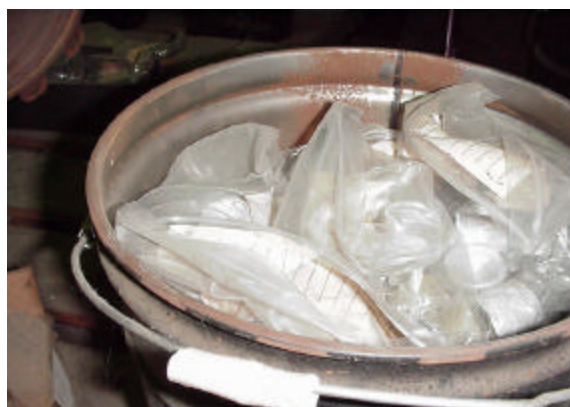
Exhibit 11 - Nickel and aluminum sample buttons.

Thirty-eight aluminum button samples obtained during ingot pours have been analyzed by ICP mass spectrometry. Thorium-230 (^{230}Th), ^{239}Pu and ^{240}Pu were present in most samples. Natural uranium isotopes were also present in low concentration with total uranium concentrations less than 30 pCi/g. Maximum concentrations for ^{230}Th , ^{239}Pu , ^{240}Pu and ^{233}U were 66 pCi/g, 212 pCi/g, 424 pCi/g, and 18 pCi/g, respectively. (ORNL reports that these numbers are only good to +/-50%.) These values represent the highest actinide concentrations found in any metal.

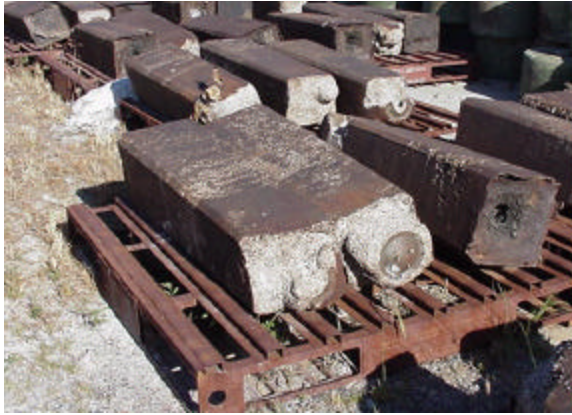
Exhibit 12 - Contaminated steel ingots.

8, 1981 (**Exhibit 12**). Approximately 22,000

lbs. of contaminated steel was melted before termination of the test due to excessive depletion of the furnace liner. Samples from 10 ingots were composited and analyzed for their respective contaminants. These data show that the levels of contaminants are reduced during smelting. However, termination of the project was due to the following problems:

- The induction furnace liner (95% aluminum oxide and 5% magnesium oxide) proved to be incompatible with the slag formed during steel smelting. The slag came from the high iron oxide level covering the surface of the scrap steel; this oxide preferentially attaches to the magnesium oxide, thus accelerating liner erosion.
- An excessive amount of slag would collect at the surface of the molten mass and tend to harden and crust over in cooler areas above the induction coils. The crust formation complicated steel recharging and pouring of ingots. The crust had to be manually broken and removed creating potential safety problems.
- The collection of slag at the surface of the molten mass increased the possibility of
- contaminant carryover into the ingots.
